UNITED STATES
DEPARTMENT OF THE INTERIOR
BUREAU OF RECLAMATION

HYDRAULIC LABORATORY TESTS OF SEALS FOR
HIGH-HEAD COASTER AND FIXED WHEEL
STRUCTURAL STEEL GATES

Hydraulic Laboratory Report No. Hyd. -311

July 20, 1951

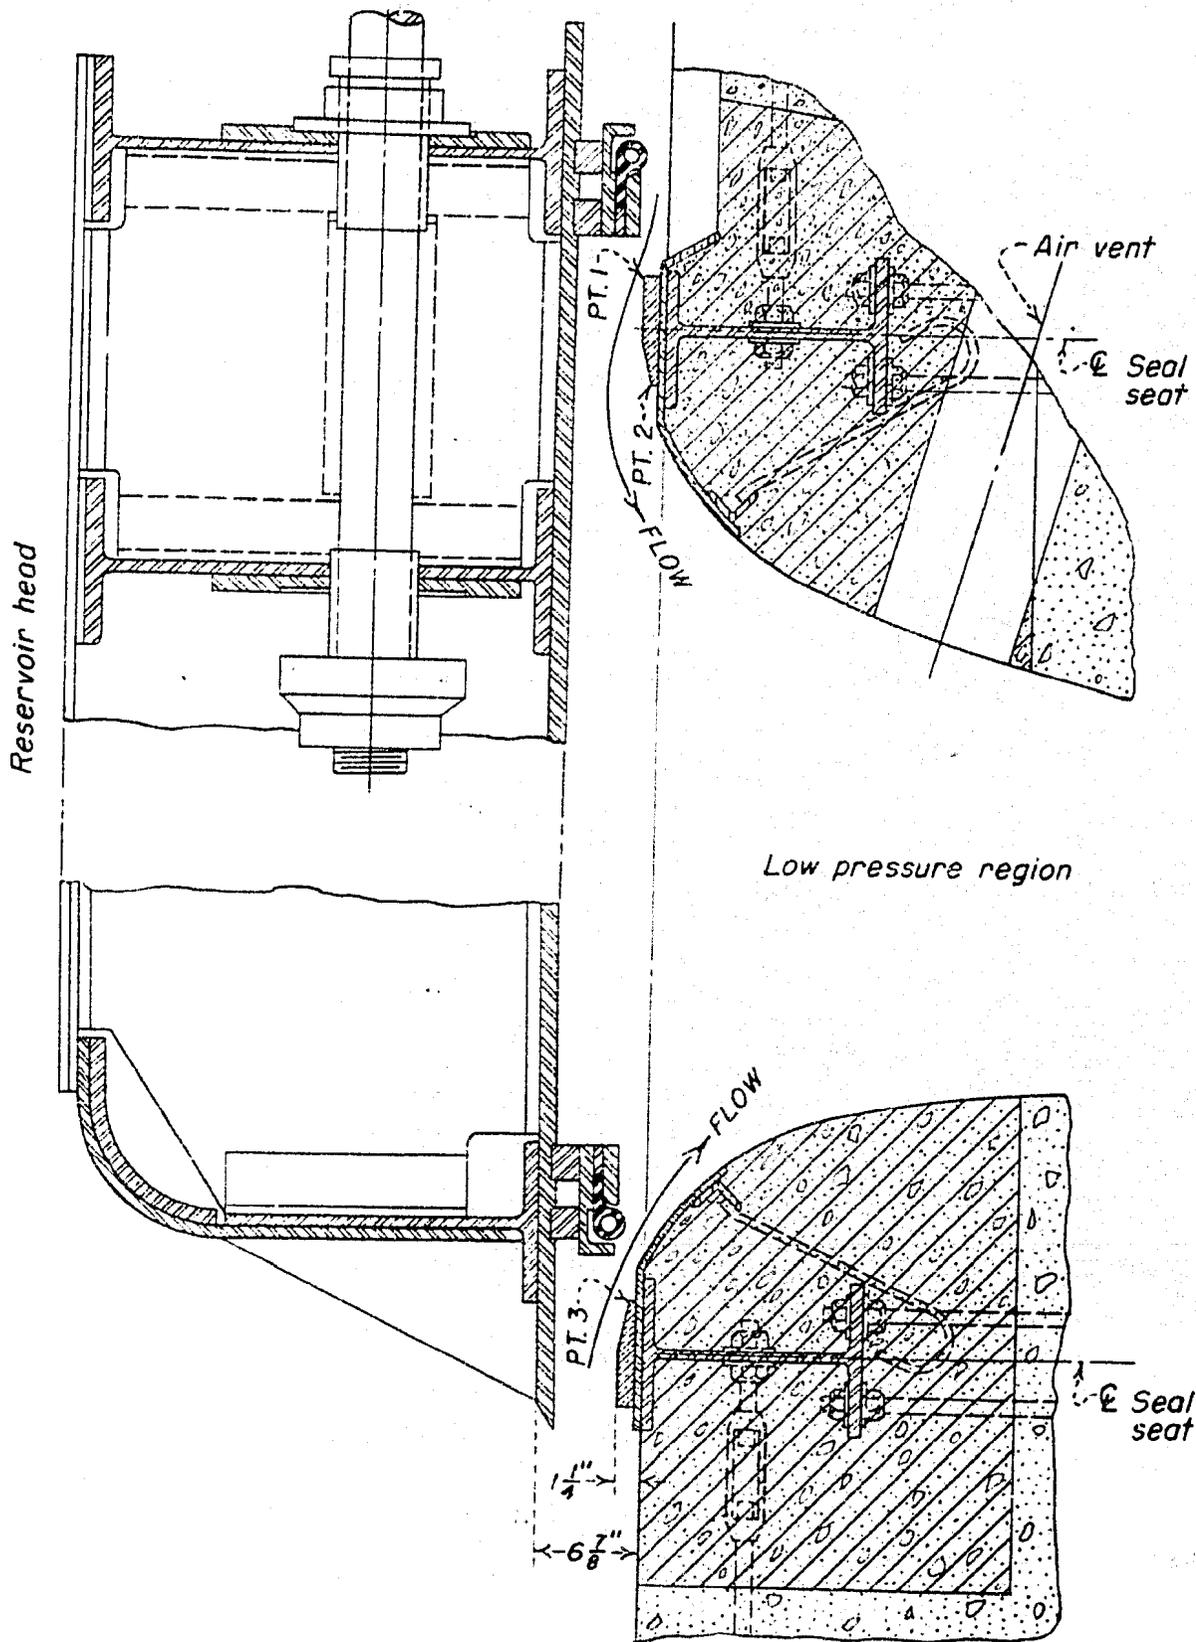
HIGH HEAD GATE SEAL STUDIES
SEAL SEAT WITH UNDESIRABLE SHARP CORNERS
AT POINTS 1, 2 AND 3

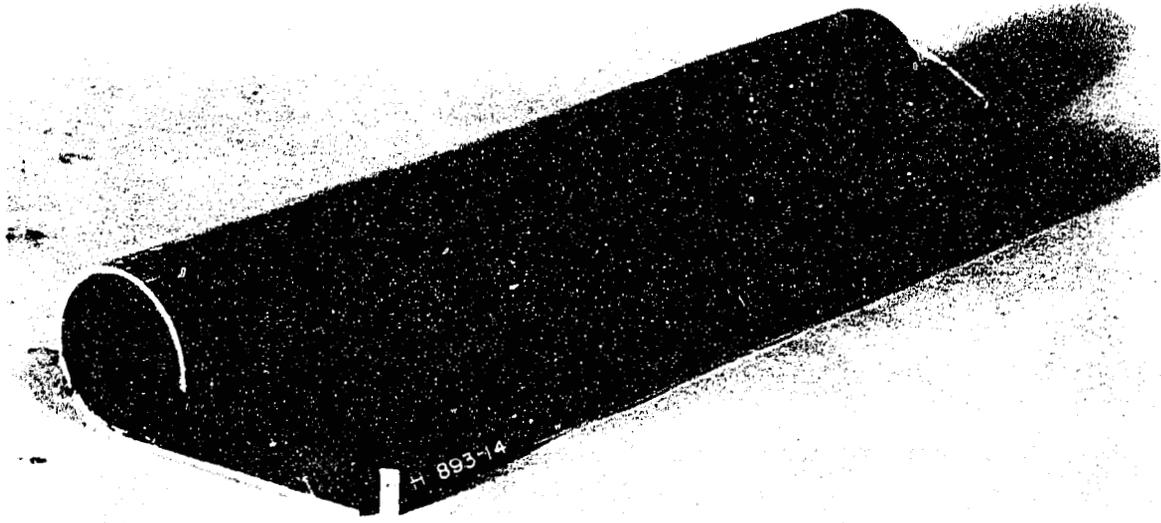
The primary failing of these seals was the poor bond between the brass and the rubber, as may be seen in Figure 16. Further, if the seal bulb was severely pinched, between the stem clamp plate and seat, the bent shield around the bulb does not return to its full round shape. Also, if the shield on the outside of the stem bent appreciably, it did not return to its flat shape. Two seal sections with different shield designs were tested with continuous extension of the seal bulb, by having the five 1/4-inch pipe holes open in the angle iron.

A. Note the poor bond between brass shield and rubber which was typical on seals with large shields.

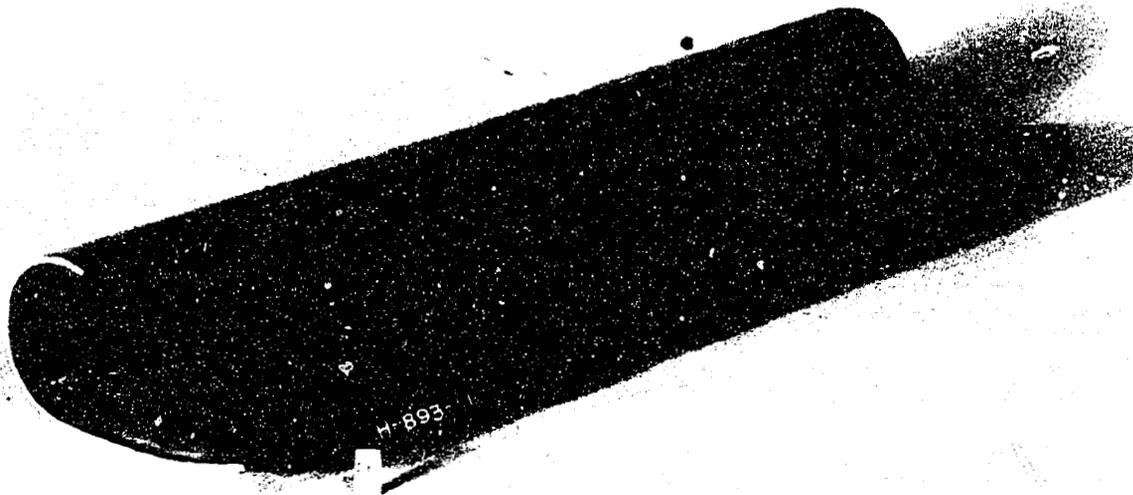
A solid bulb seal with a brass shield on the outside of the stem and continuing around to the bulb center line is shown in Figure 16B. However, the shield slipped past the bulb center line during the curing operation on the section tested. With the only change in the test gate assembly of zero seal-to-seat gap, the behavior of this seal was observed for gate openings and closures at 60-, 92-, and 150-foot head. At the 150-foot head, gate closure was impossible because the seal bulb caught on the seal seat at the upper corner of the bevel (Figure 15B). This very clearly shows that a brass shield is required on the upper quarter of the bulb surface adjacent to the stem to prevent the bulb from "wrapping" itself around the lower end of the clamp plate as shown. Nearly 100 percent of the bond area was broken between the rubber and brass shielding on the stem.

B. Brass shield slipped during molding and shield does not reach to end of stem. The bent shield is the result of laboratory tests.

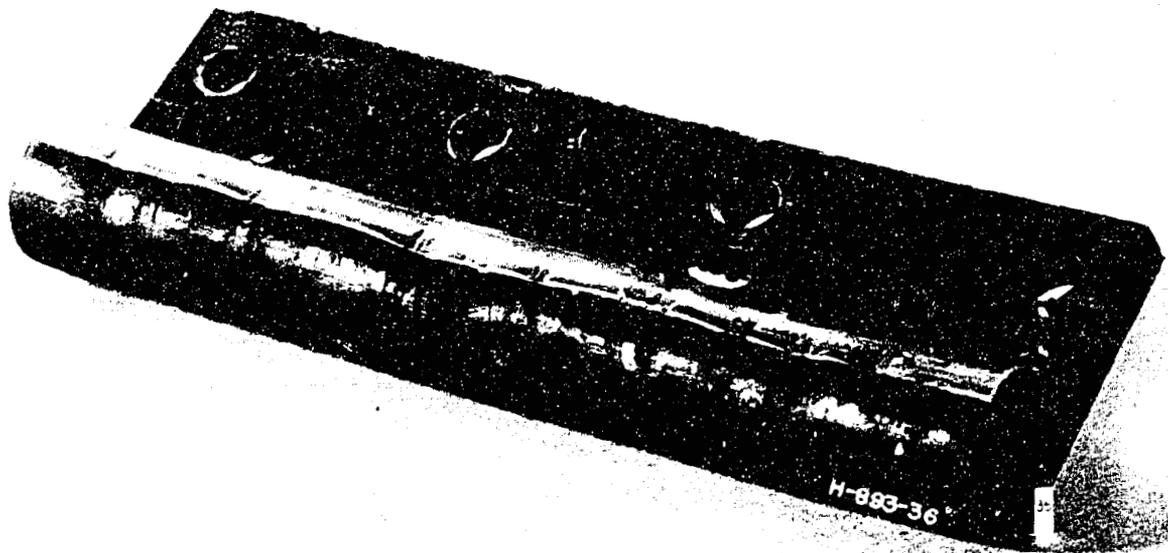
B. Solid bulb music note seal with 90 degree brass shield on bulb. This seal was used with the above seat. The damage was sustained in seating.

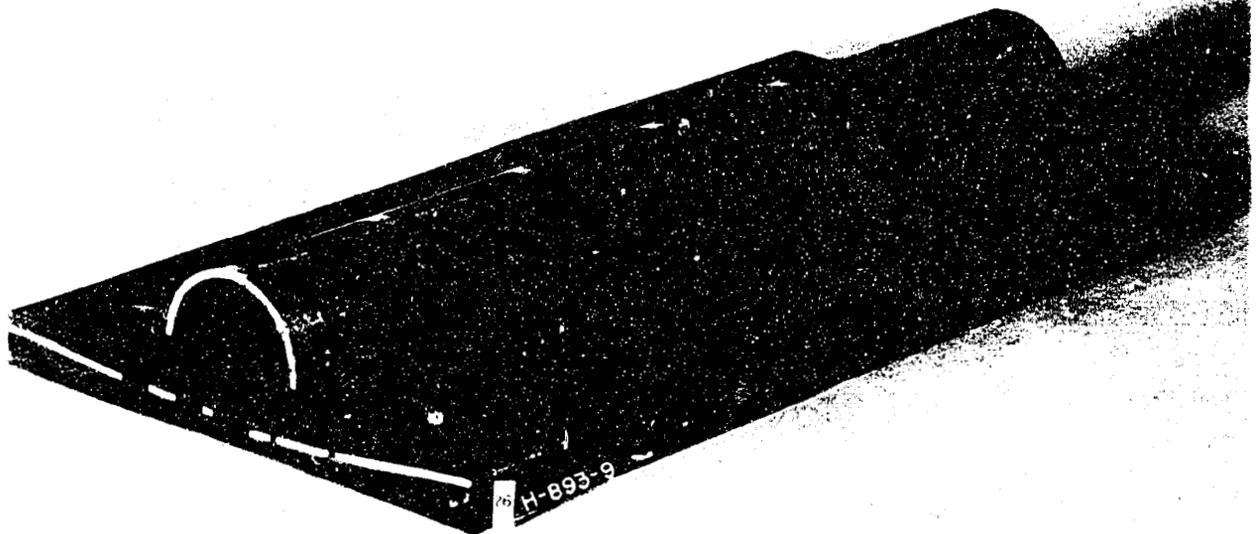
B. Seal with 180 degree, slotted brass bulb shield. Two piece, brass stem reinforcing plate shifted during molding. (See Figure 27).

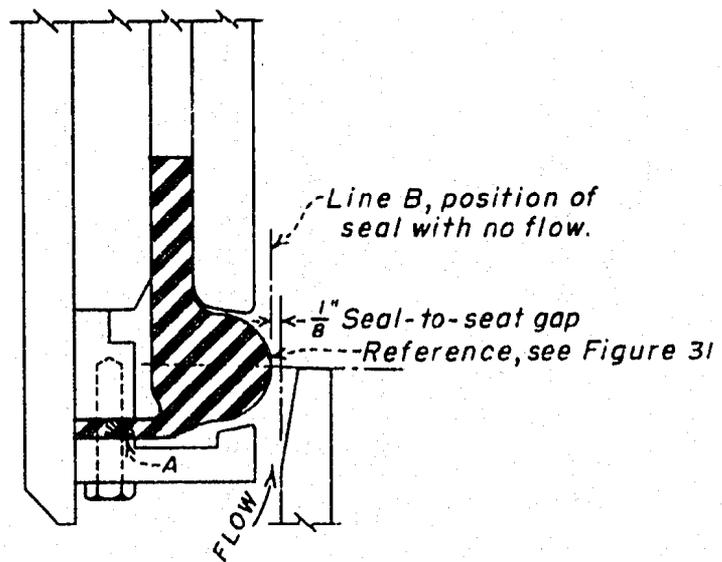
(a) With 1/8-inch seal-to-seat gap, the bulb could not be retracted after it had been extended at reservoir heads of 97 or more feet because of excessive leakage into the cavity behind the seal bulb (Figure 33). The holes in the thin-bolted section for the three 3/8-inch cap screws and the four 7/16-inch-diameter spacers elongated when the bulb was extended. The spacers were required so that the cap screws could be tightened and to prevent the plate below the seal from turning counterclockwise. When an attempt was made to drain the cavity behind the bulb for retraction, the elongated holes continued to leak reservoir head into the cavity; thus, the seal bulb did not retract. If the bulb will not retract, it will become pinched on the upper corner of the seat bevel.

The seal bulb remained extended above 97 feet of head because water leaked through the four $7/16$ " diameter spacer pin holes in the thin rubber bolted section, point "A". These holes were stretched to an elliptical shape. When bulb retraction was attempted, the pressure behind the bulb could not be reduced sufficiently for retraction. Similar leakage is likely to occur through cap-screw holes.

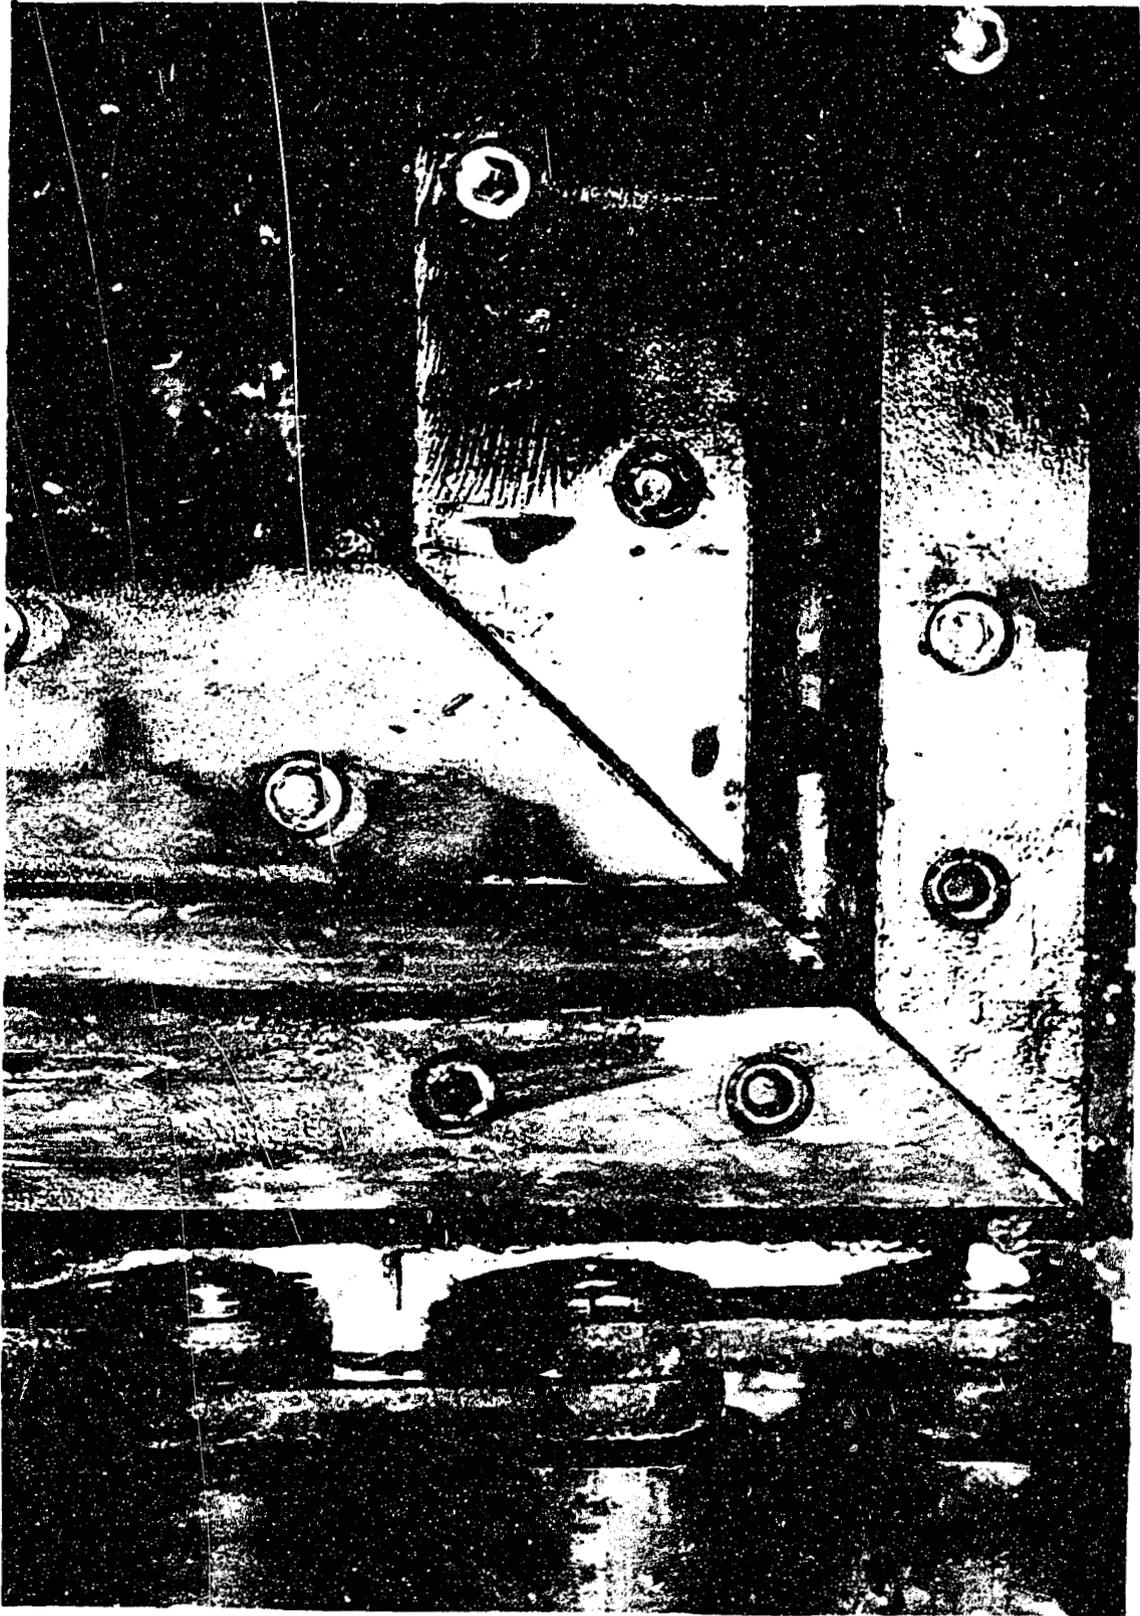
The special rubber seal (Drawing No. 222-D-14970) is shown on the R-6 coaster gate after completion of the simulated emergency closure tests. The photo shows the condition of the lower east corner of the seal. October 11, 1950.

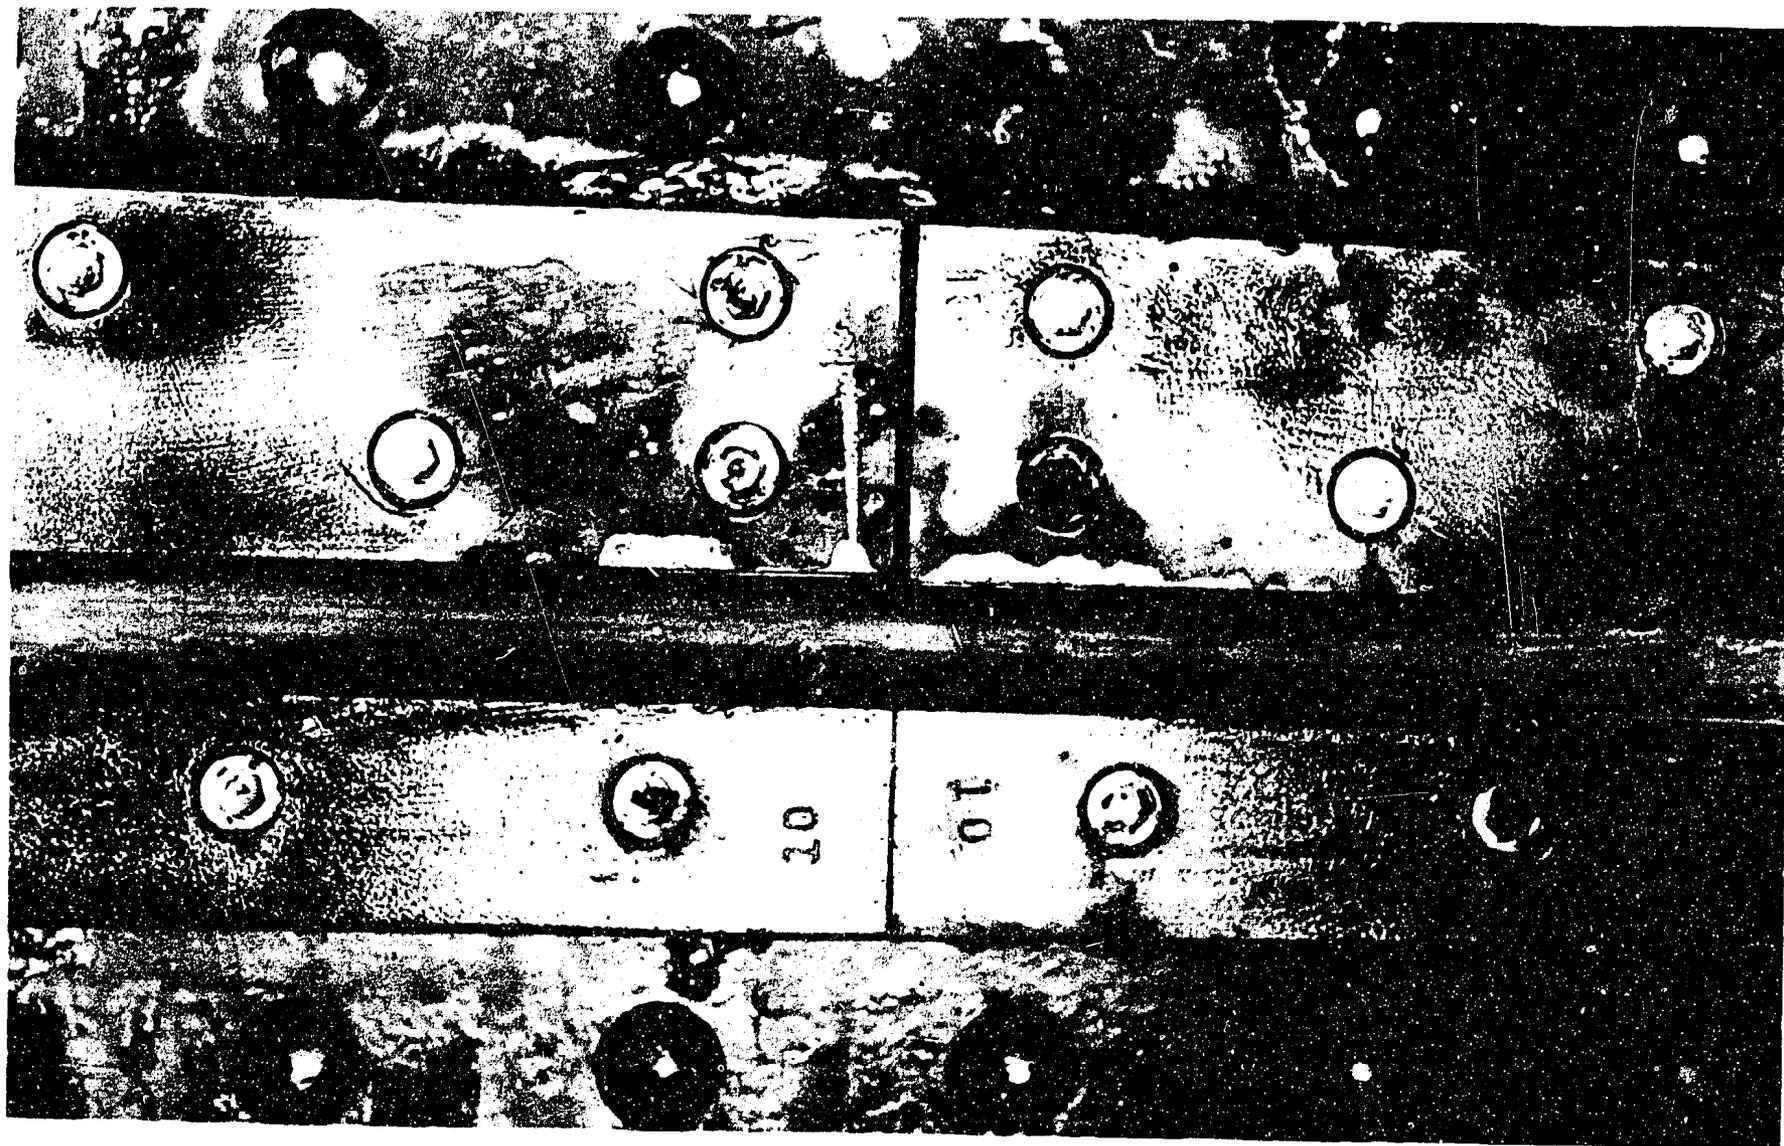
The special rubber seal (Drawing No. 222-D-14970) is shown on the R-6 coaster gate after completion of the simulated emergency closure tests. The photo shows the condition of the midpoint of the lower seal. October 11, 1950.

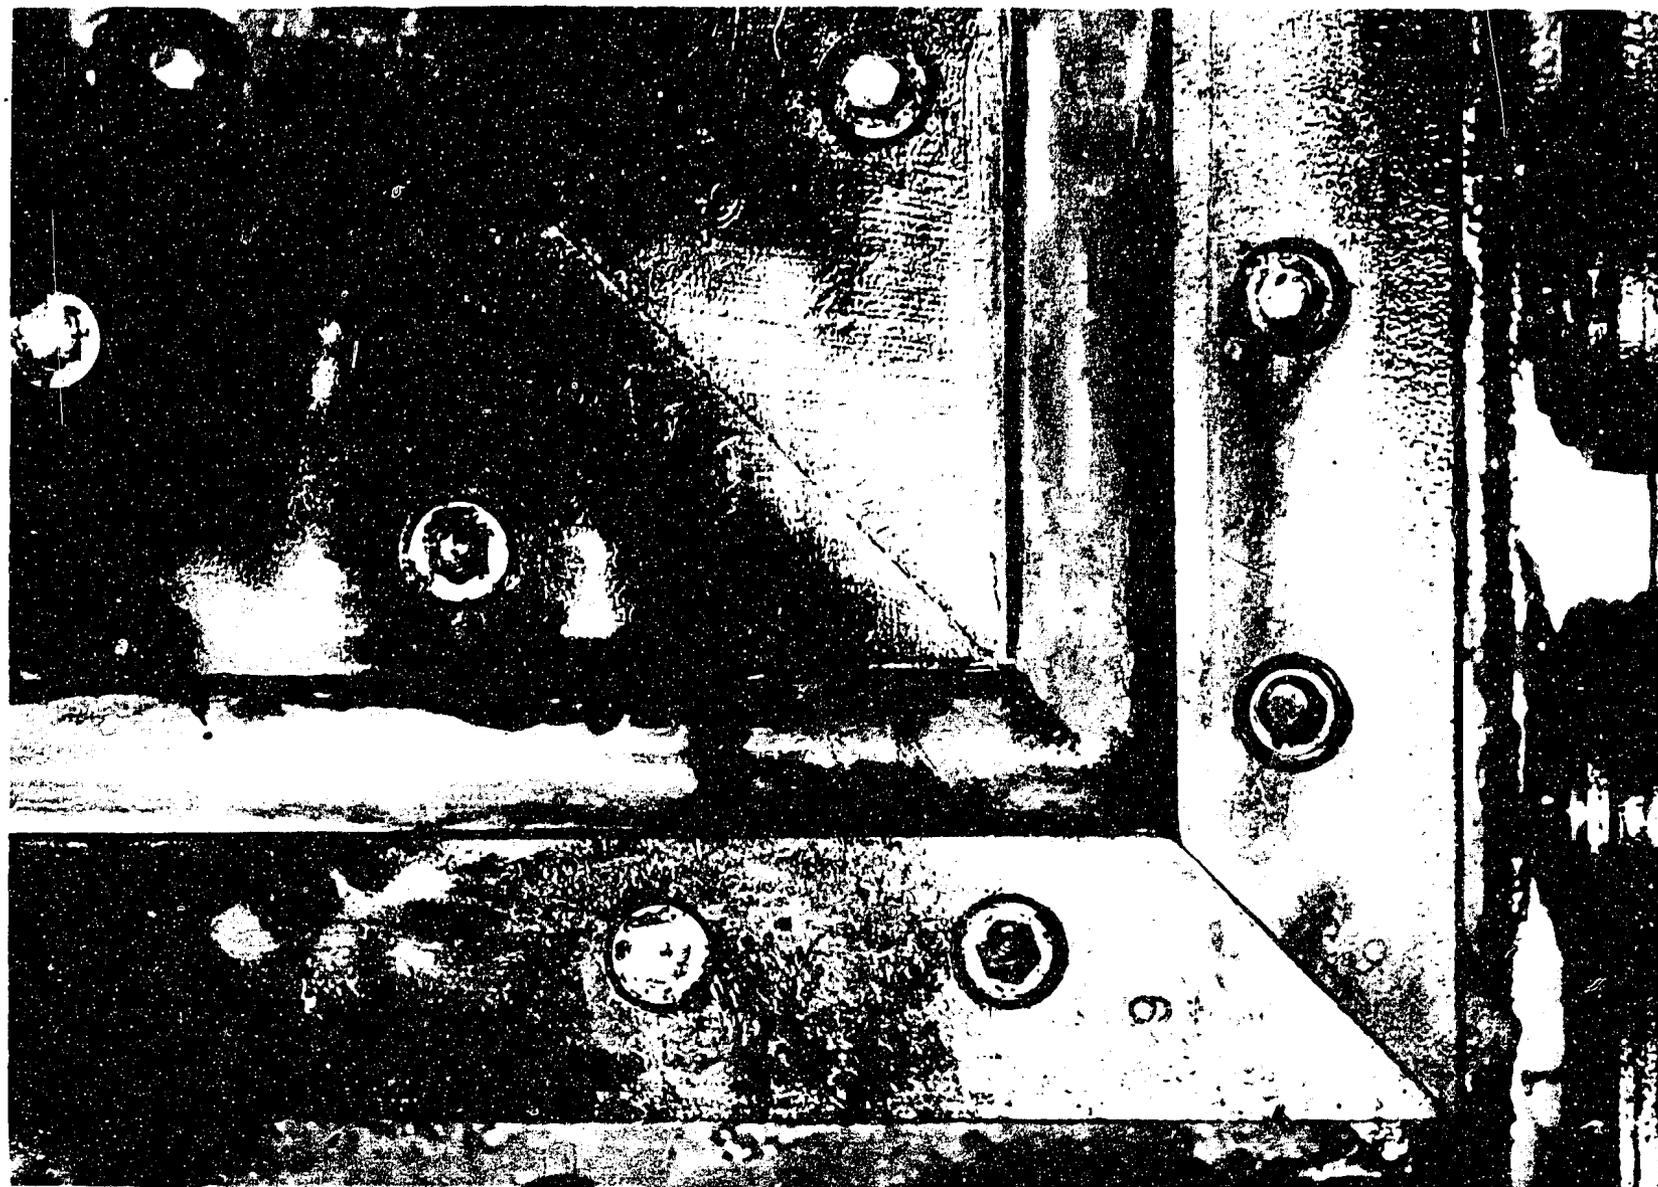
The special rubber seal (Drawing No. 222-D-14970) is shown on the R-6 coaster gate after completion of the simulated emergency closure tests. The photo shows the condition of the lower west corner of the seal. Note the space between the lower clamp bar and the seal. October 11, 1950.

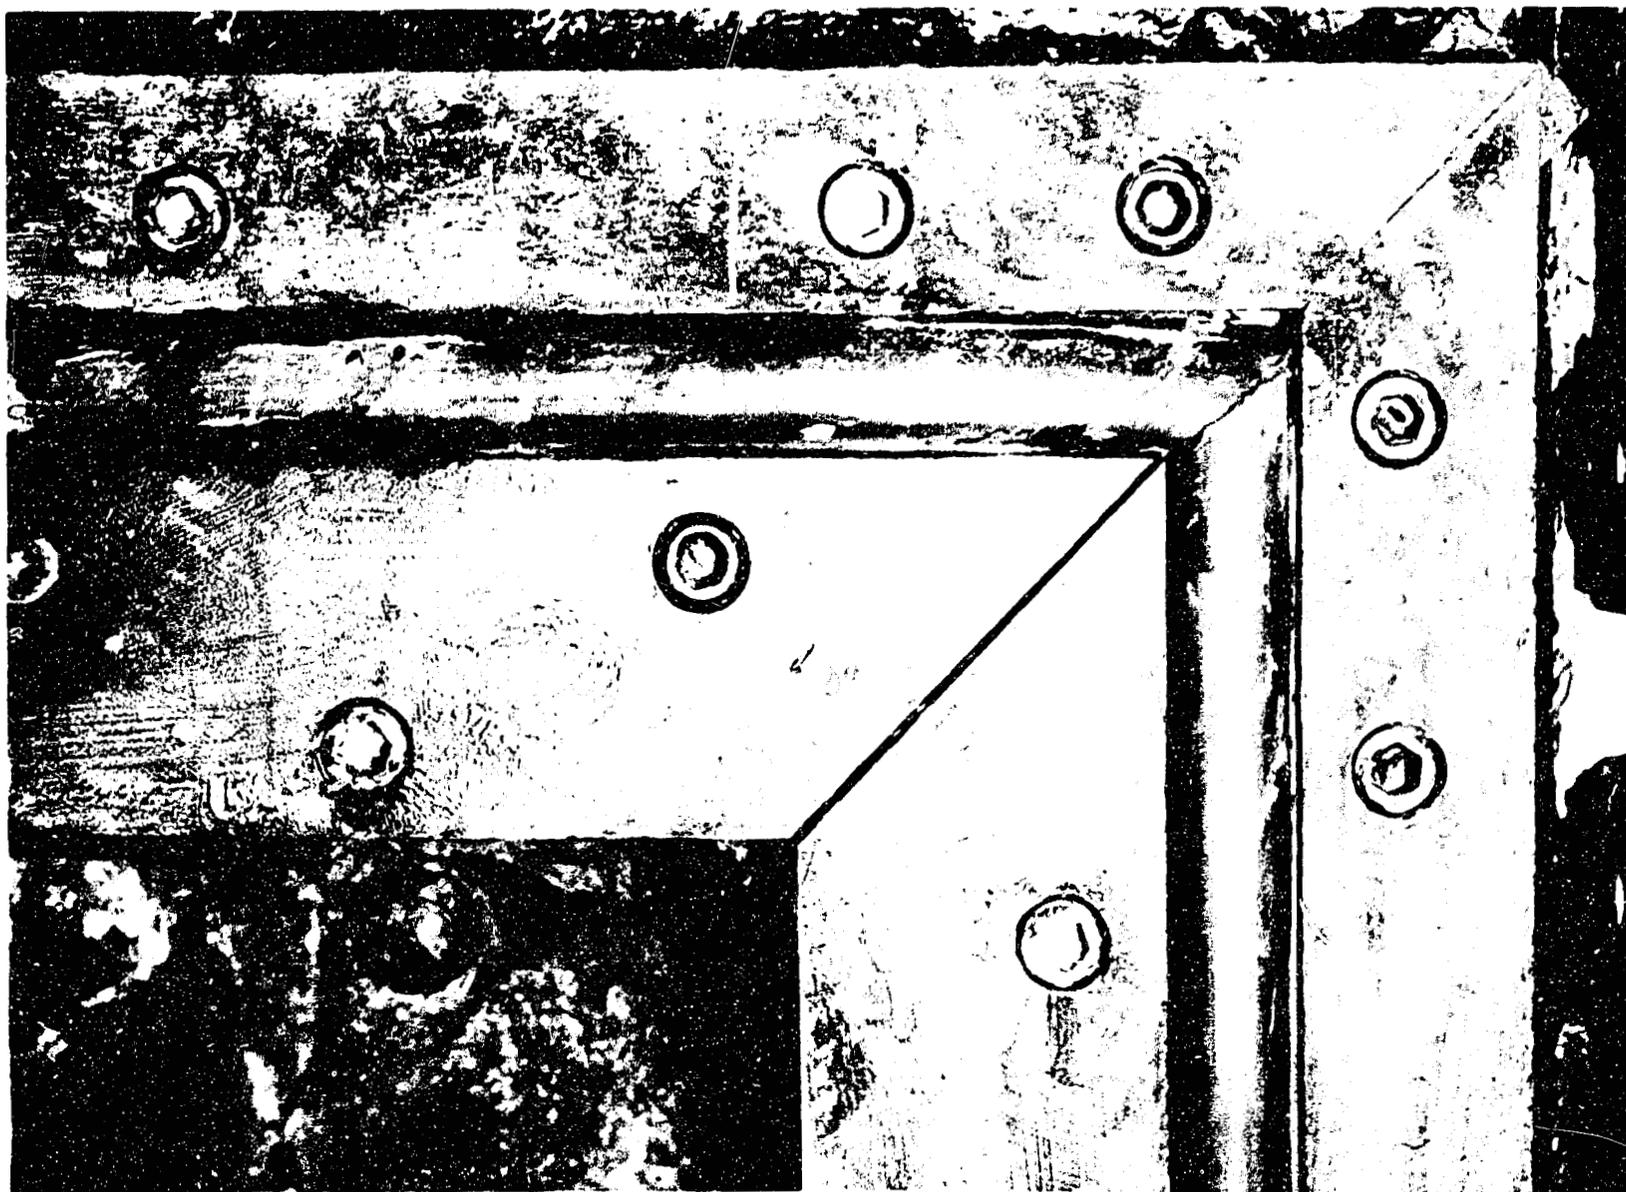
The special rubber seal (Drawing No. 222-D-14970) is shown on the R-6 coaster gate after completion of the simulated emergency closure tests. The photo shows the upper west corner of the seal. The pulled down condition of the seal at the corner was present before the tests and does not appear to have been altered during the tests. October 11, 1950.
